AFATL-TR-79-20

**Residual Levels of
2,3,7,8-Tetrachlorodibenzo-p-Dioxin
(TCDD) Near Herbicide Storage and
Loading Areas at Eglin AFB, Florida**

FEBRUARY 1979

FINAL REPORT FOR PERIOD JANUARY 1976-DECEMBER 1978

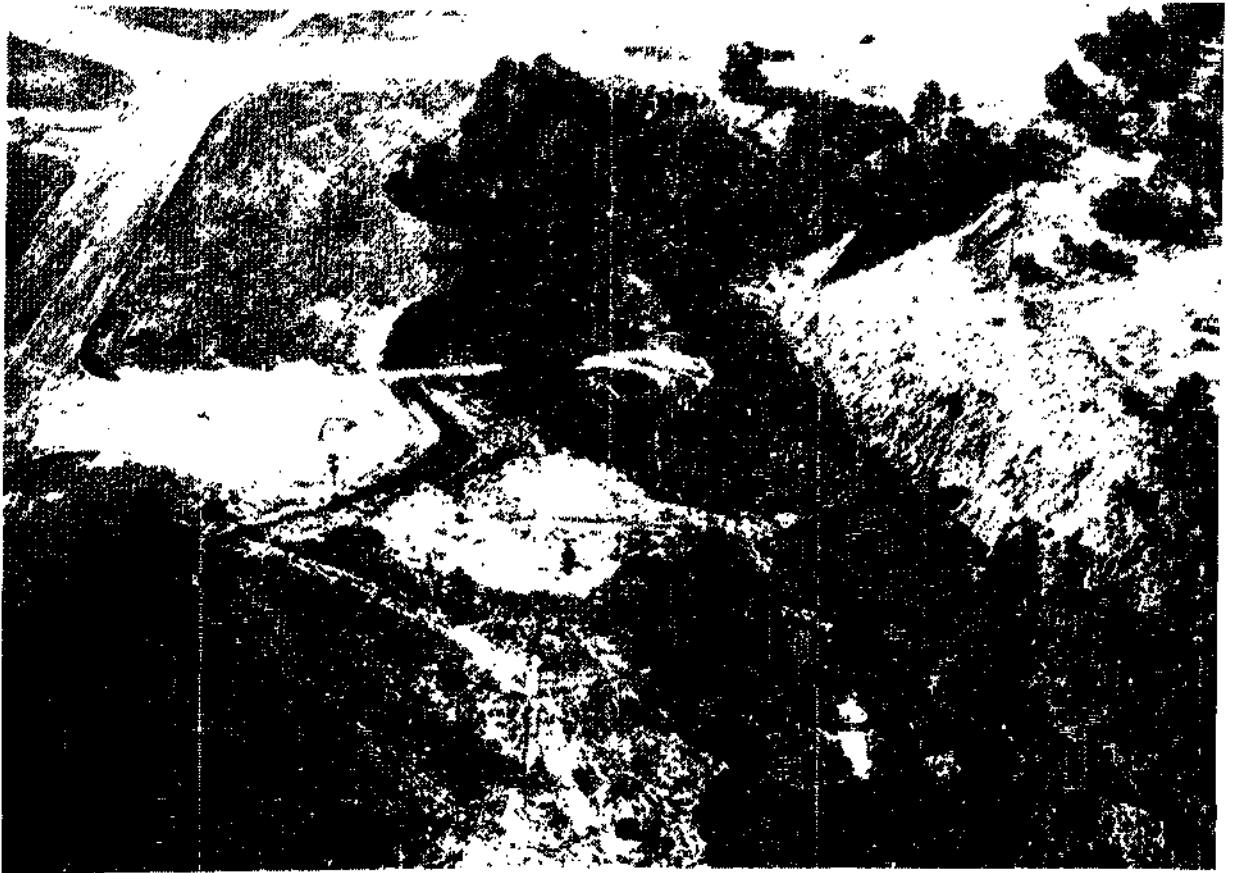
Figure 4. Aerial View of Hardstand 7, Eglin AFB, Florida

Hardstand 7 (Figure 4) is an asphalt and concrete aircraft parking area located west of the north-south runway on the main Eglin airdrome, approximately 65 feet (20 meters) above sea level. The hardstand is connected to the airdrome by an asphalt taxiway. This hardstand was the most extensively used site for herbicide storage and loading during the 1962 through 1970 spray test program. The soil of this area is sandy with good drainage properties. Directly behind the hardstand is a ravine that drops off approximately 15 meters to a small pond (Figure 5). Because of the packing caused by vehicular traffic and the water-repellent nature of the oil-based herbicide contamination, runoff of excess water caused an erosion problem in some spots which led to the frequent use of fill dirt. Eventually, a dike covered with asphalt was constructed on the rim of the ravine for soil stabilization. A storm drain was also installed to help control erosion. The pond behind Hardstand 7 drains into a small stream which flows north until it enters a man-made reservoir named Beaver Pond (Figure 6). The drainage system eventually flows into Tom's Bayou and Choctawhatchee Bay.

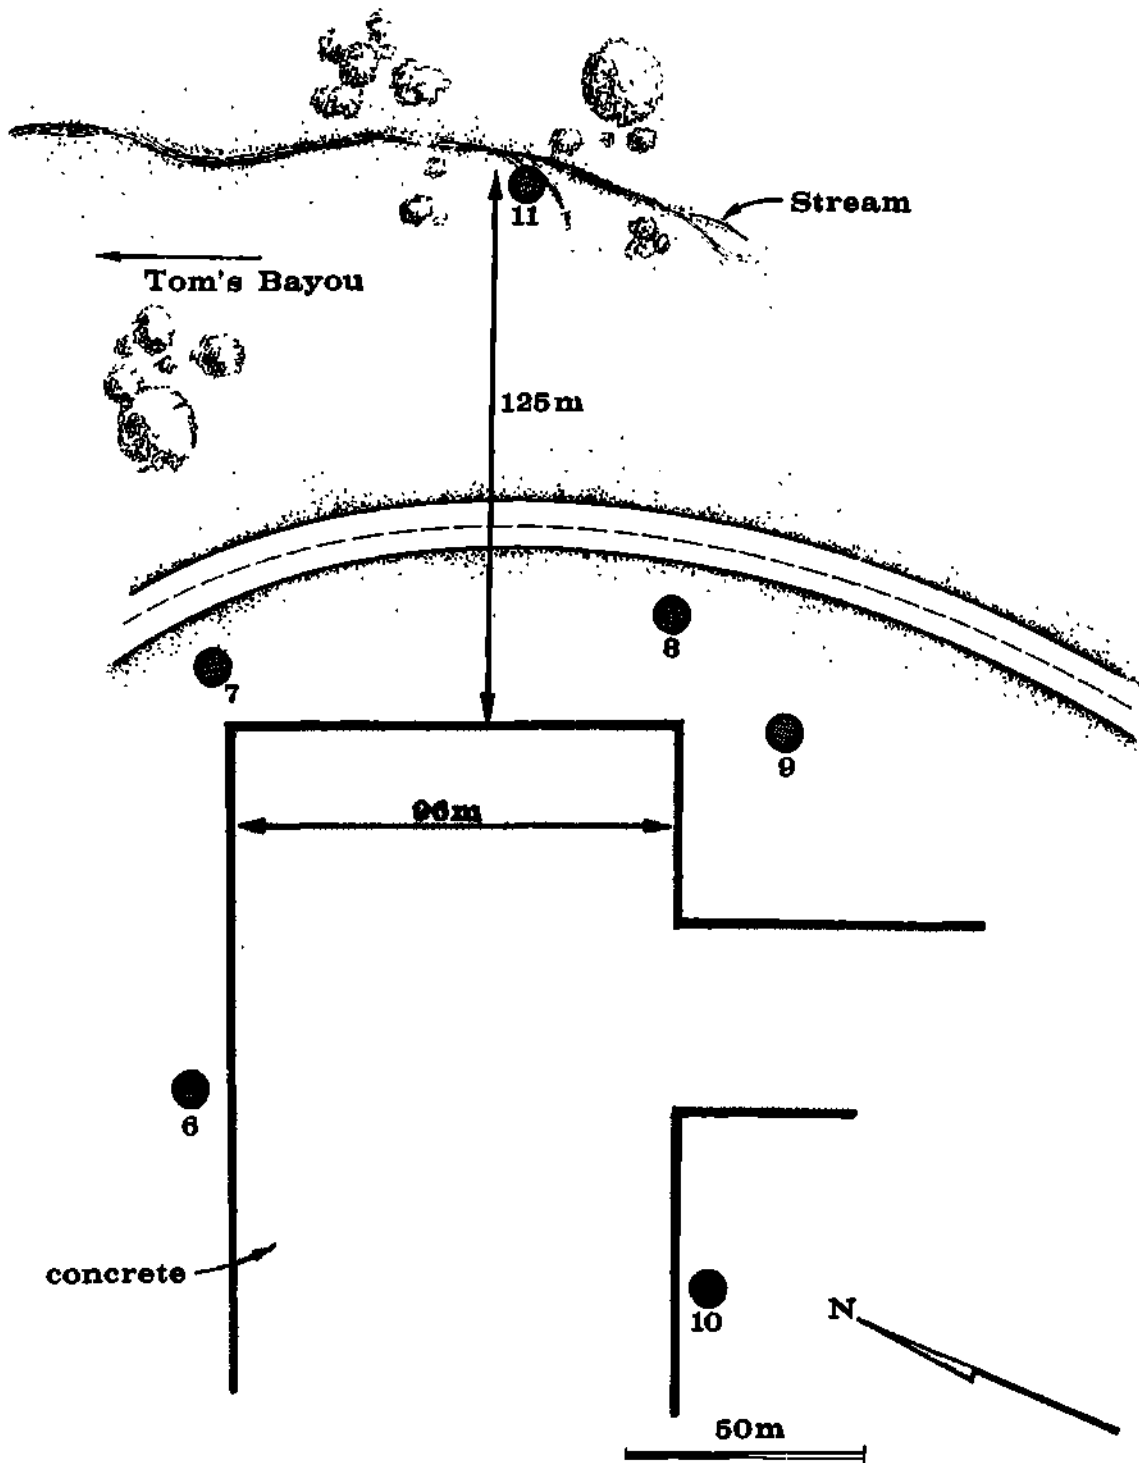
Figure 10. Soil Sampling Sites at East End of Taxiway Number 9, Eglin AFB, Florida

In January 1976, five soil samples were taken from the east end of Taxiway Number 9 and one sediment sample from the exit of the storm sewer drain (Figure 10). The soil samples were taken from the top 10 cm at sites considered to be likely areas for herbicide contamination. No TCDD was found in any of the samples (Table 3).
