Minutes A/A45Y-1 Internal Defoliant Dispenser System Support Conference, 25 and 26 August 1966

A/A45Y-1 INTERNAL DEFOLIANT DISPENSER SYSTEM

SUPPORT CONFERENCE

25 AND 26 AUGUST 1966

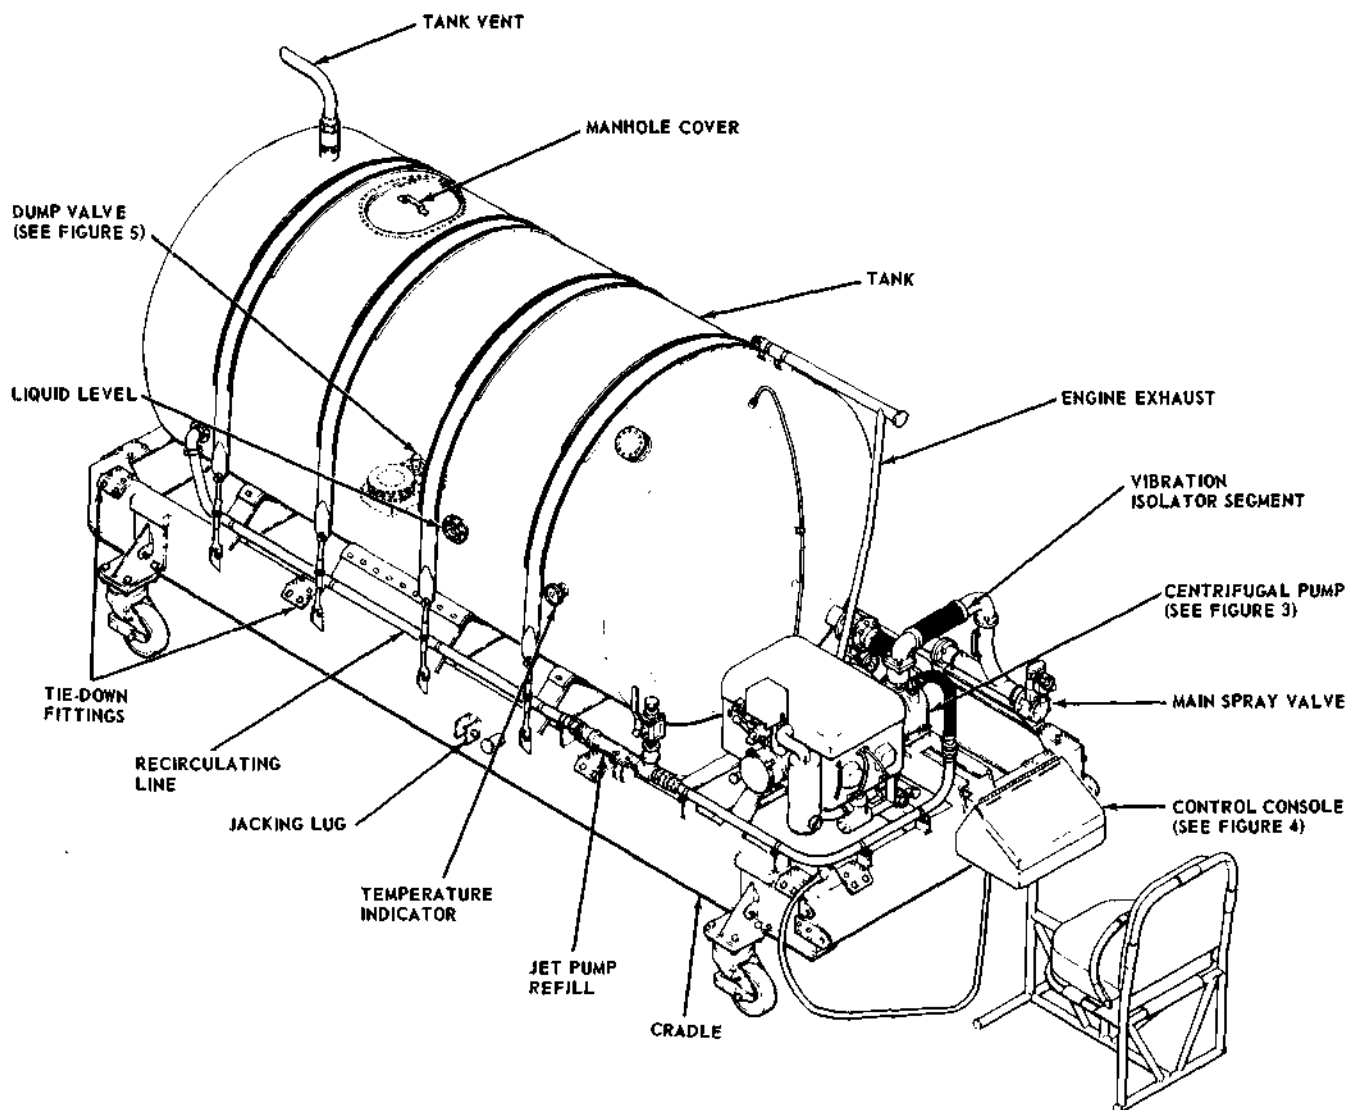
Figure 1. Major Components of Defoliant Dispenser

The internal defoliant dispenser is capable of containing 1000 gallons of defoliant which can be completely dumped overboard by remote control or manually in less than 45 seconds. The pump is capable of maintaining 60 ± 5 psi pressure during the normal 3- to 4-minute period of operational spraying. Refilling the tank assembly is accomplished with power and equipment contained within the defoliation dispensing system.

NOTE:
SEE FIGURE 6 FOR TAIL
BOOM AND FIGURE 7 FOR
WING BOOM. FIGURES 8
AND 9 SHOW A/A45Y-1
INSTALLED IN C-123 AIRCRAFT.

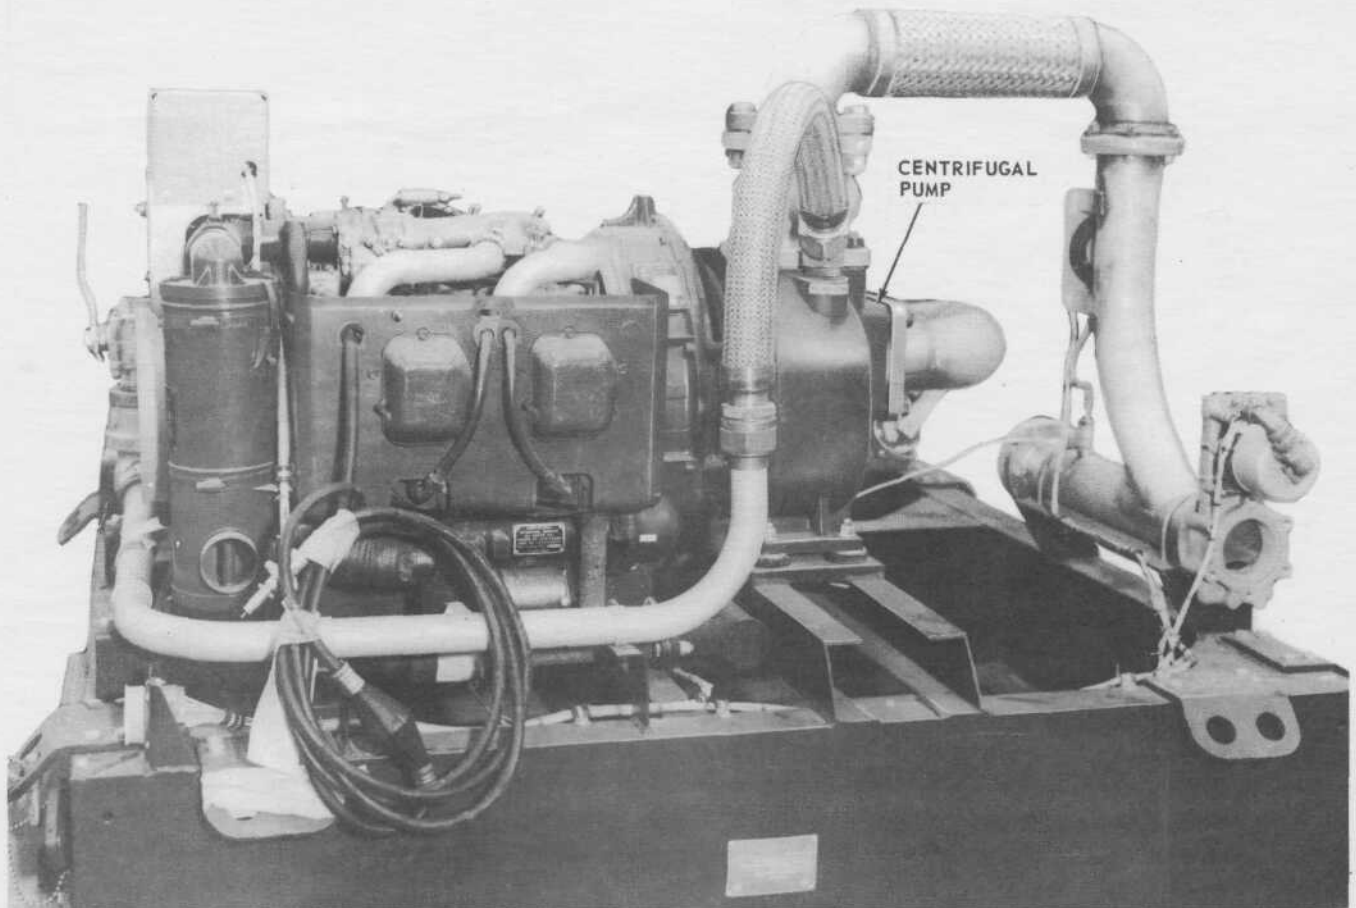
Figure 3. Centrifugal Pump

The tank and cradle assembly is the major unit of the entire system, having a 1000-gallon tank with baffles, manhole, tube connections, and stabilizing and tie-down brackets; an engine and pump assembly which consists of a four cylinder, horizontally opposed air-cooled, engine and pump directly coupled to the engine

crankshaft; and a cradle which carries the tank, the engine and pump assembly, and is provided with four casters which are readily detachable. A temperature indicator and a liquid level gage are installed in the tank. The engine is slightly modified from its original configuration to achieve adaptability to the requirements of the dispenser system. The detachable casters are to provide limited mobility and are removed when the unit is tied down.

The centrifugal pump consists essentially of an impeller and a pump body, and is driven by the engine through a direct drive. The engine drives the pump and the speed of the engine controls the quantity of defoliant being dispensed. (See figure 3.)

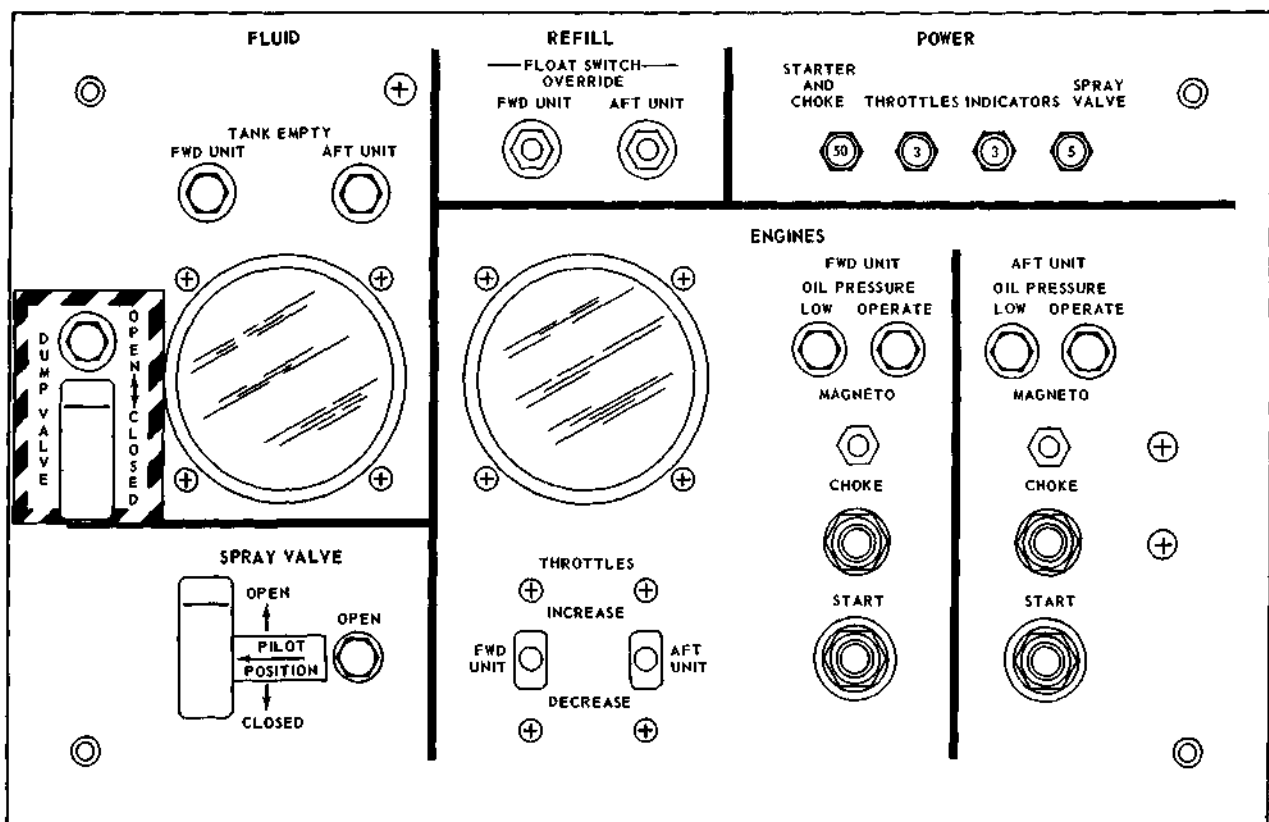
Figure 4. Control Console

The control console is the nerve center of the defoliation system. All functions are controlled from this position; all monitoring equipment is located in this position; and the electrical supply is channeled and protected at this position. Prefabricated electrical cables tie the control console to all related

parts of the system, including the controls on the pilot's instrument panel and the aircraft electrical supply system. Tandem or single installations are controlled and monitored from the control console without any changes or alterations being performed. In the event of electrical power failure of the aircraft electrical system, certain critical functions have an option of manual operation. (See figure 4.)

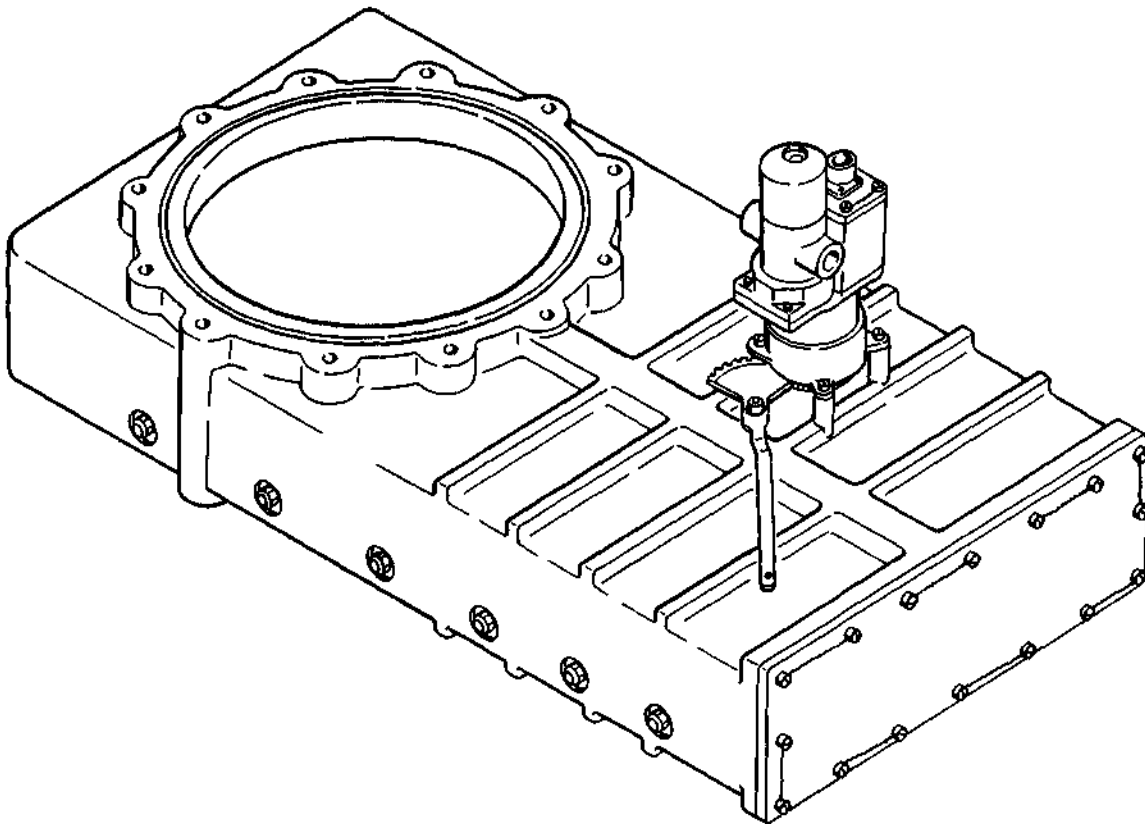
Figure 5. Dump Valve

The dump valve is a 10 inch gate valve having both electrical or manual activation. It is designed for horizontal (vertical flow) installation and liquid flow in only one direction. The bottom of the defoliant tank incorporates a vortex interrupter and adapter to which the dump valve is secured and is in perfect alignment with an opening and spring loaded door in the belly of the aircraft. A high speed motor coupled to an actuator provides 2 second operation of the dump valve in either direction and circuit manipulation to indicate open condition. (See figure 5.)

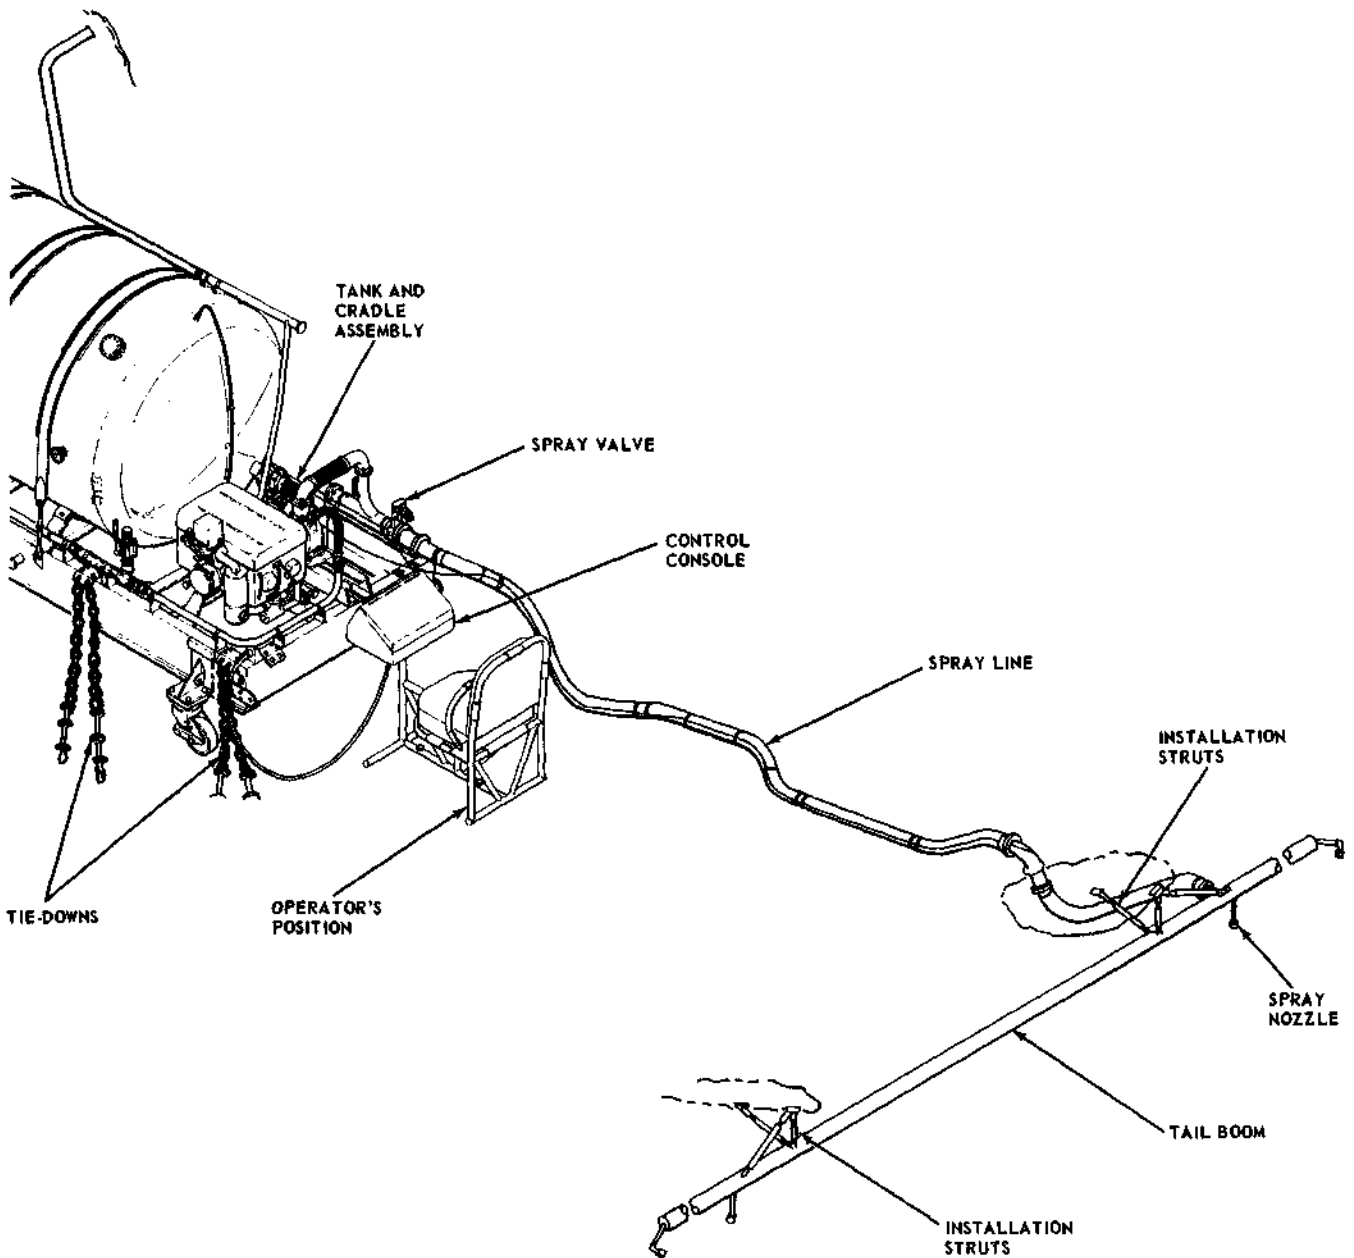
Figure 6. Tail Spray Boom and Associated Plumbing

The tail spray boom (figure 6) is mounted outside the aircraft, approximately midway of the aft cargo loading door. It is designed for simple and fast installation and removal and provides coverage of a 250 foot strip.

The prime function of the spray boom is to discharge the defoliant under pressure at such a location and at such an angle that air flow, in the proximity of the discharge (spray) nozzle, contributes to the proper density of spray, the consistency of the defoliant blanket; and the lateral dimension of the effective strip. Two spray booms are available when the C-123 model aircraft is used and each boom satisfies a specific set of requirements.

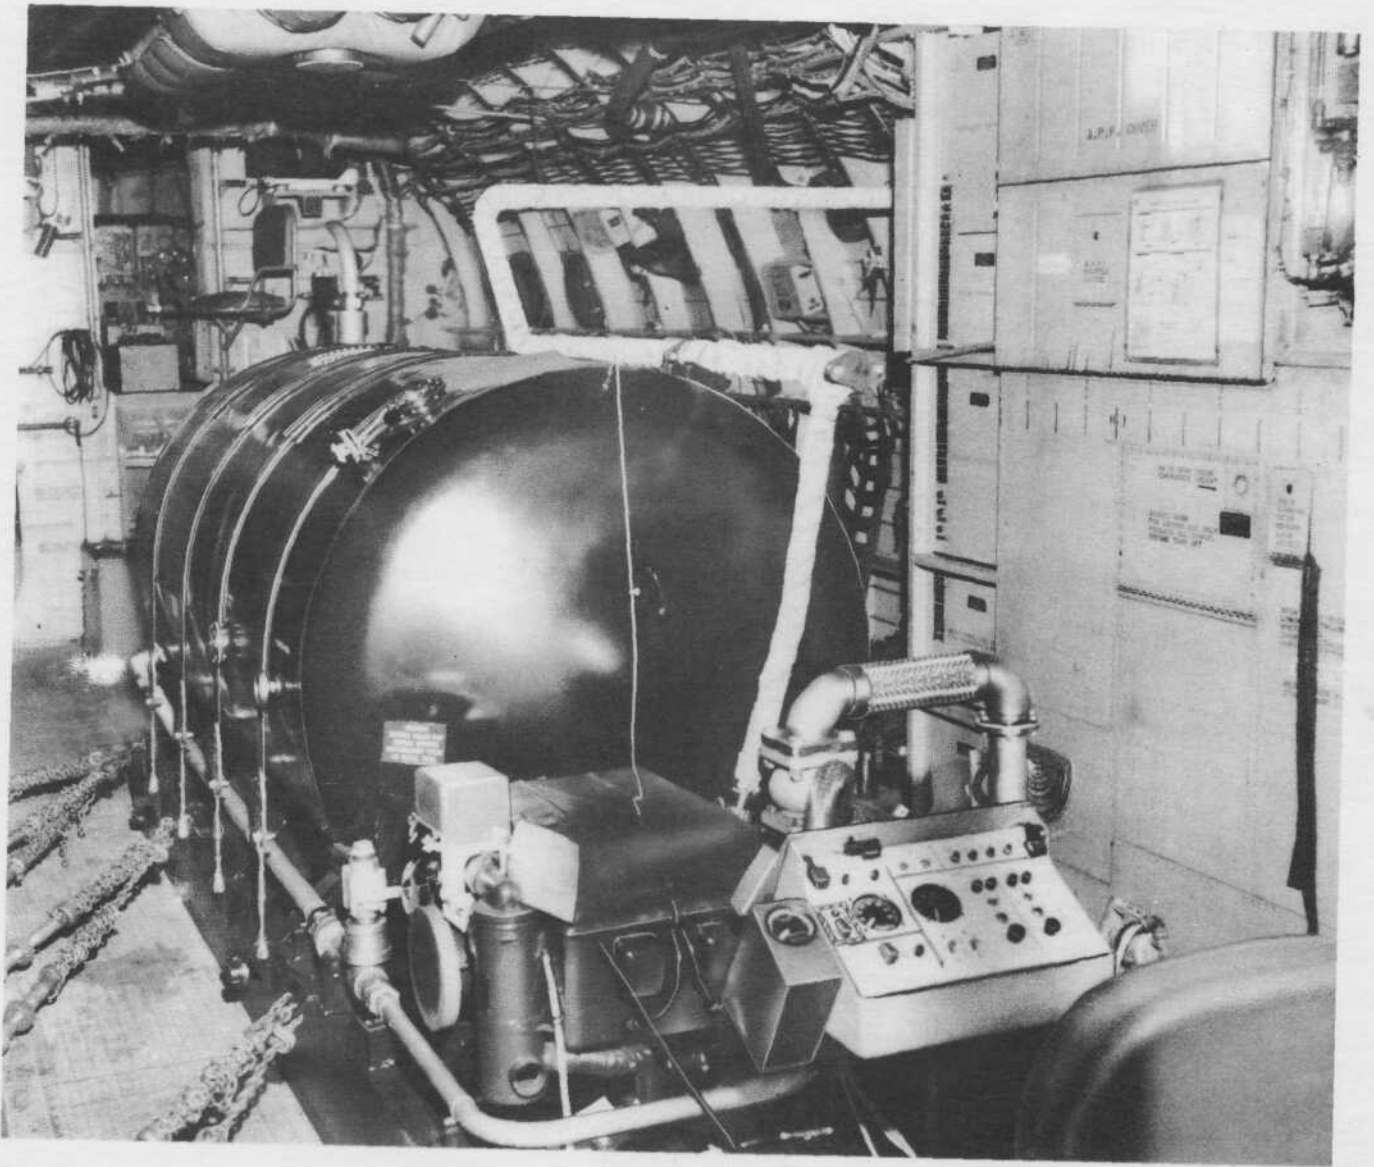
Figure 8. Installation in C-123 (left side)

The dispenser installation in C-123 aircraft consists of towing the tank and cradle assembly (unfilled) into the aircraft and securing it to the aircraft floor utilizing twenty 10,000-pound hook and chain assemblies and the cargo floor tie-down fittings (figures 8 and 9). All piping, hose assemblies and electrical cables are installed which tie the A/A45Y-1 dispenser into the aircraft (as modified) systems, and the control console is secured to the aircraft floor; thus, making the aircraft-dispenser combination ready for servicing and operation.

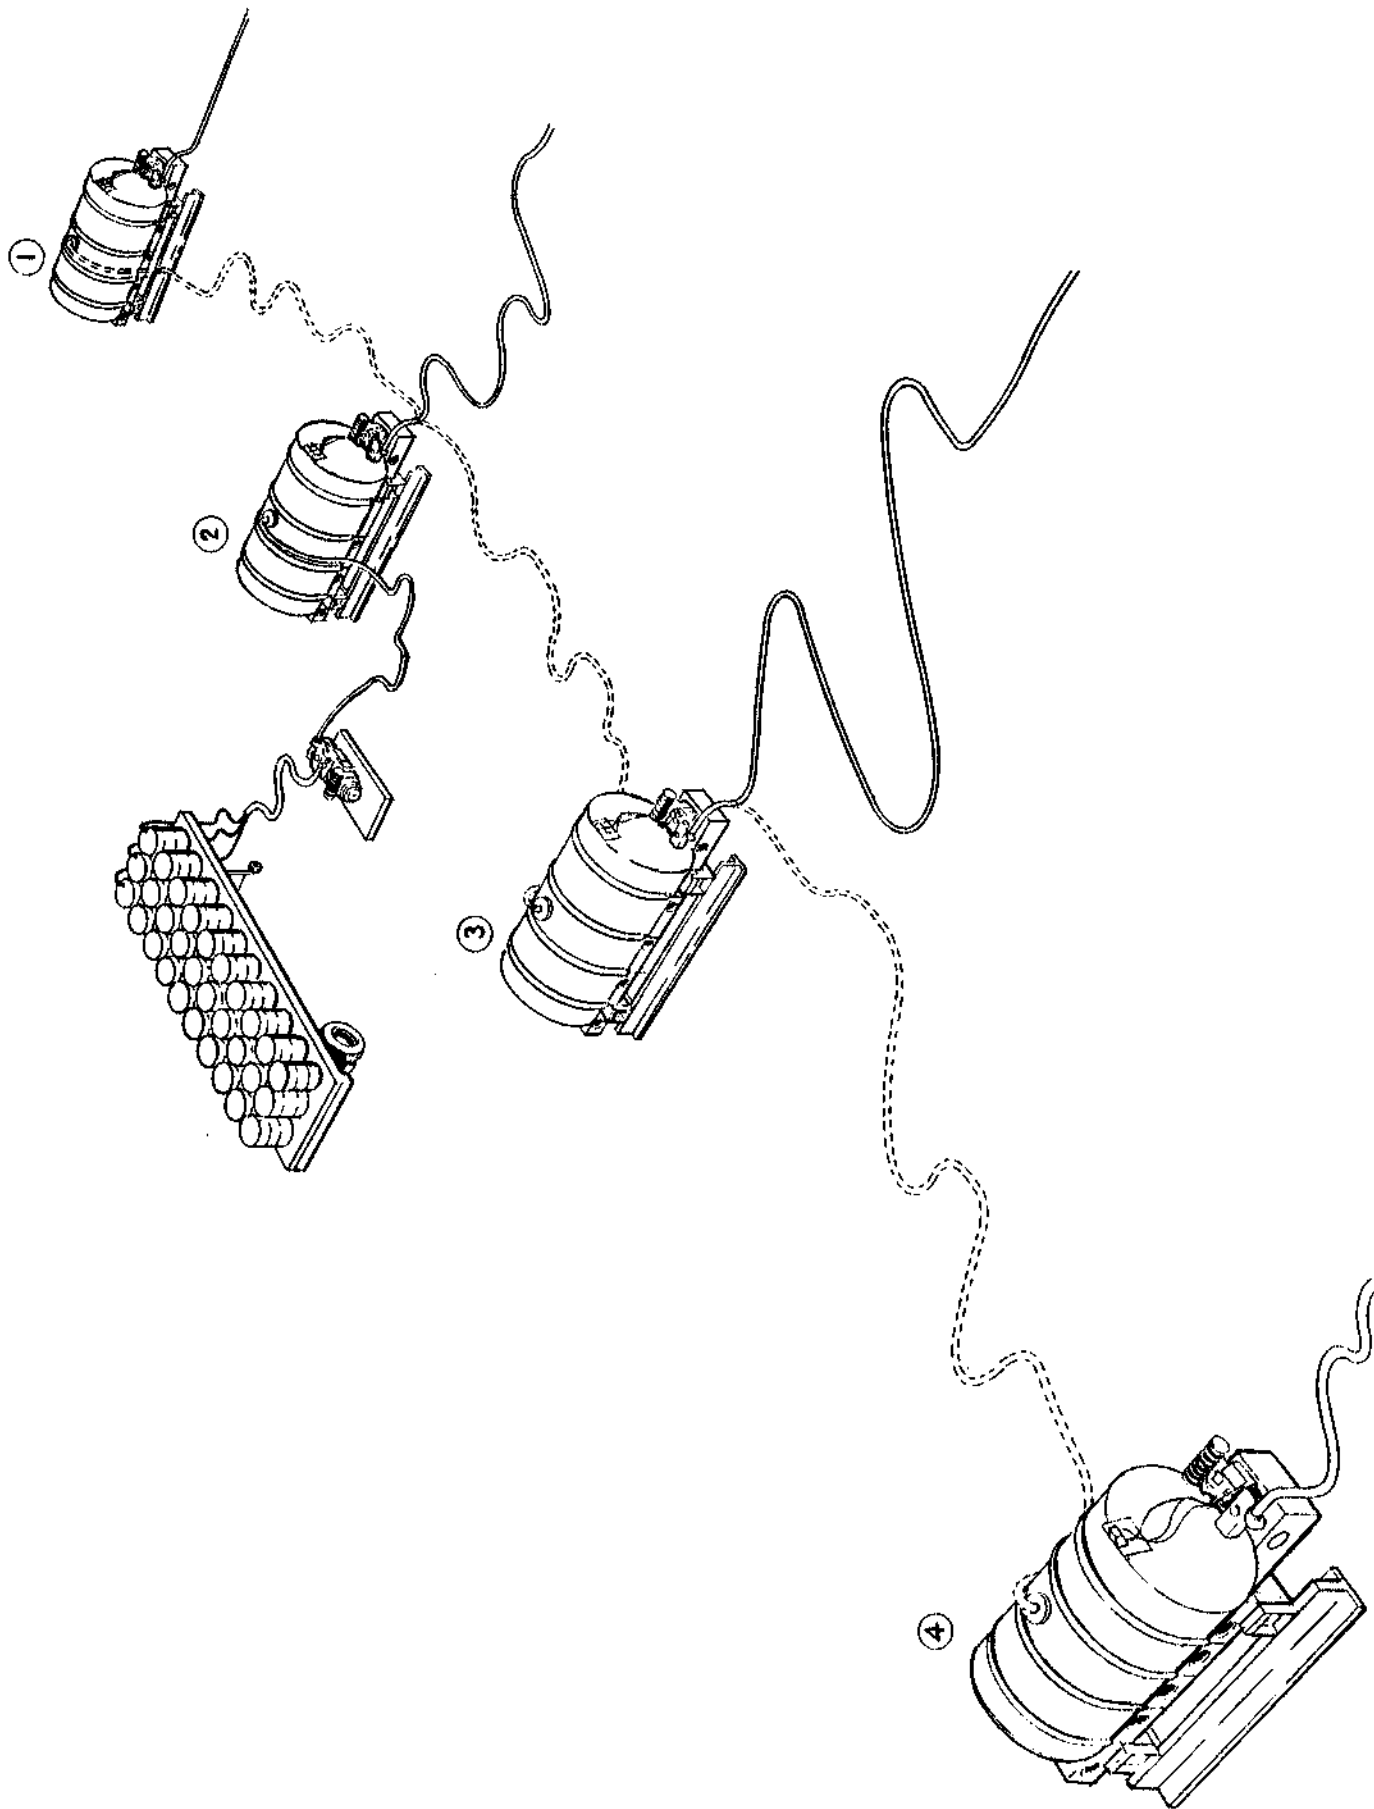
Figure 10. Existing Defoliant Transfer System Tan Son Nhut Air Base, Viet Nam

Upon return from a mission, the aircraft is backed as close as possible to the refill tanks and the systems are refilled with agent using a commercial fire hose. After completion of the days work the HOURGLASS tanks are filled and the agent transferred into the aircraft. The refill tanks are then refilled in preparation for a second mission. Due to the long time needed to fill from the drums, the RANCH HAND crews are limited to only one turn around, or a total of two missions.

A big disadvantage of refilling in this manner is the problem of contamination to the agent. Foreign matter gets into the refill tanks and from there into aircraft defoliant dispensing system. The rubber inside lining of fire hoses, presently used, is acted upon by the defoliant and causes large pieces of rubber to be released into the defoliant stream, thereby reducing the system effectiveness. See figures 11 thru 14 for potographic on-site refill operations.

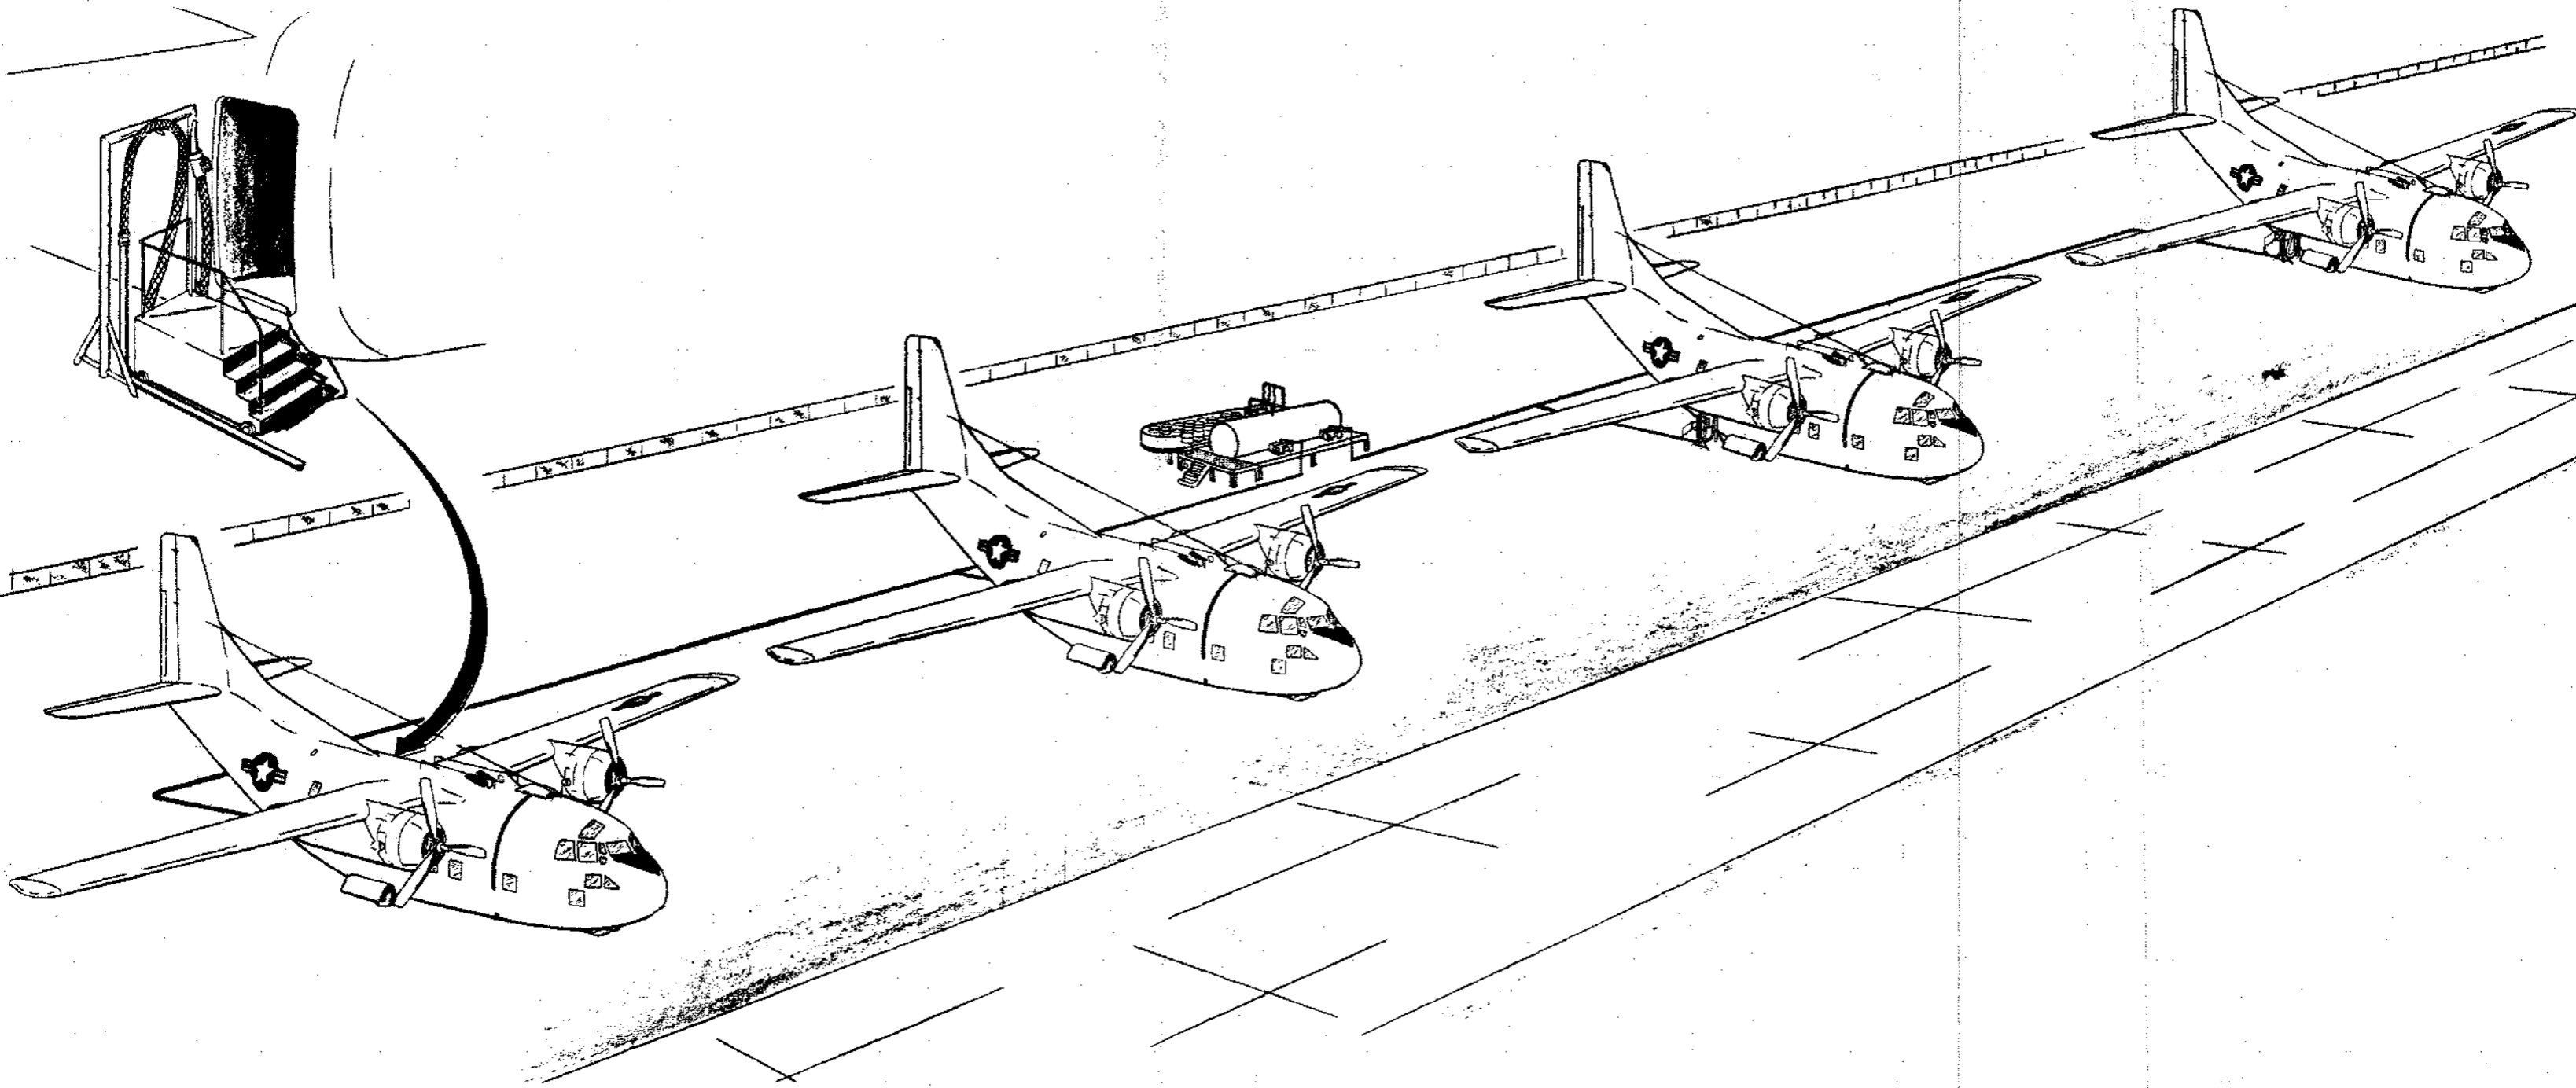
Figure 15. Optimized Defoliant Handling System Layout

The platform is a locally manufactured structure approximately the same height as a flat bed trailer and having lateral dimensions as necessary to accommodate the shape and size of the 10,000-gallon tank plus the related units. A support for a suction hose and manifold is located on the truck side of the platform and is designed so that the suction manifold is supported at approximately the centerline of the flat bed trailer. The platform deck has 1/4-inch cracks between decking members to dissipate any defoliant spillage.

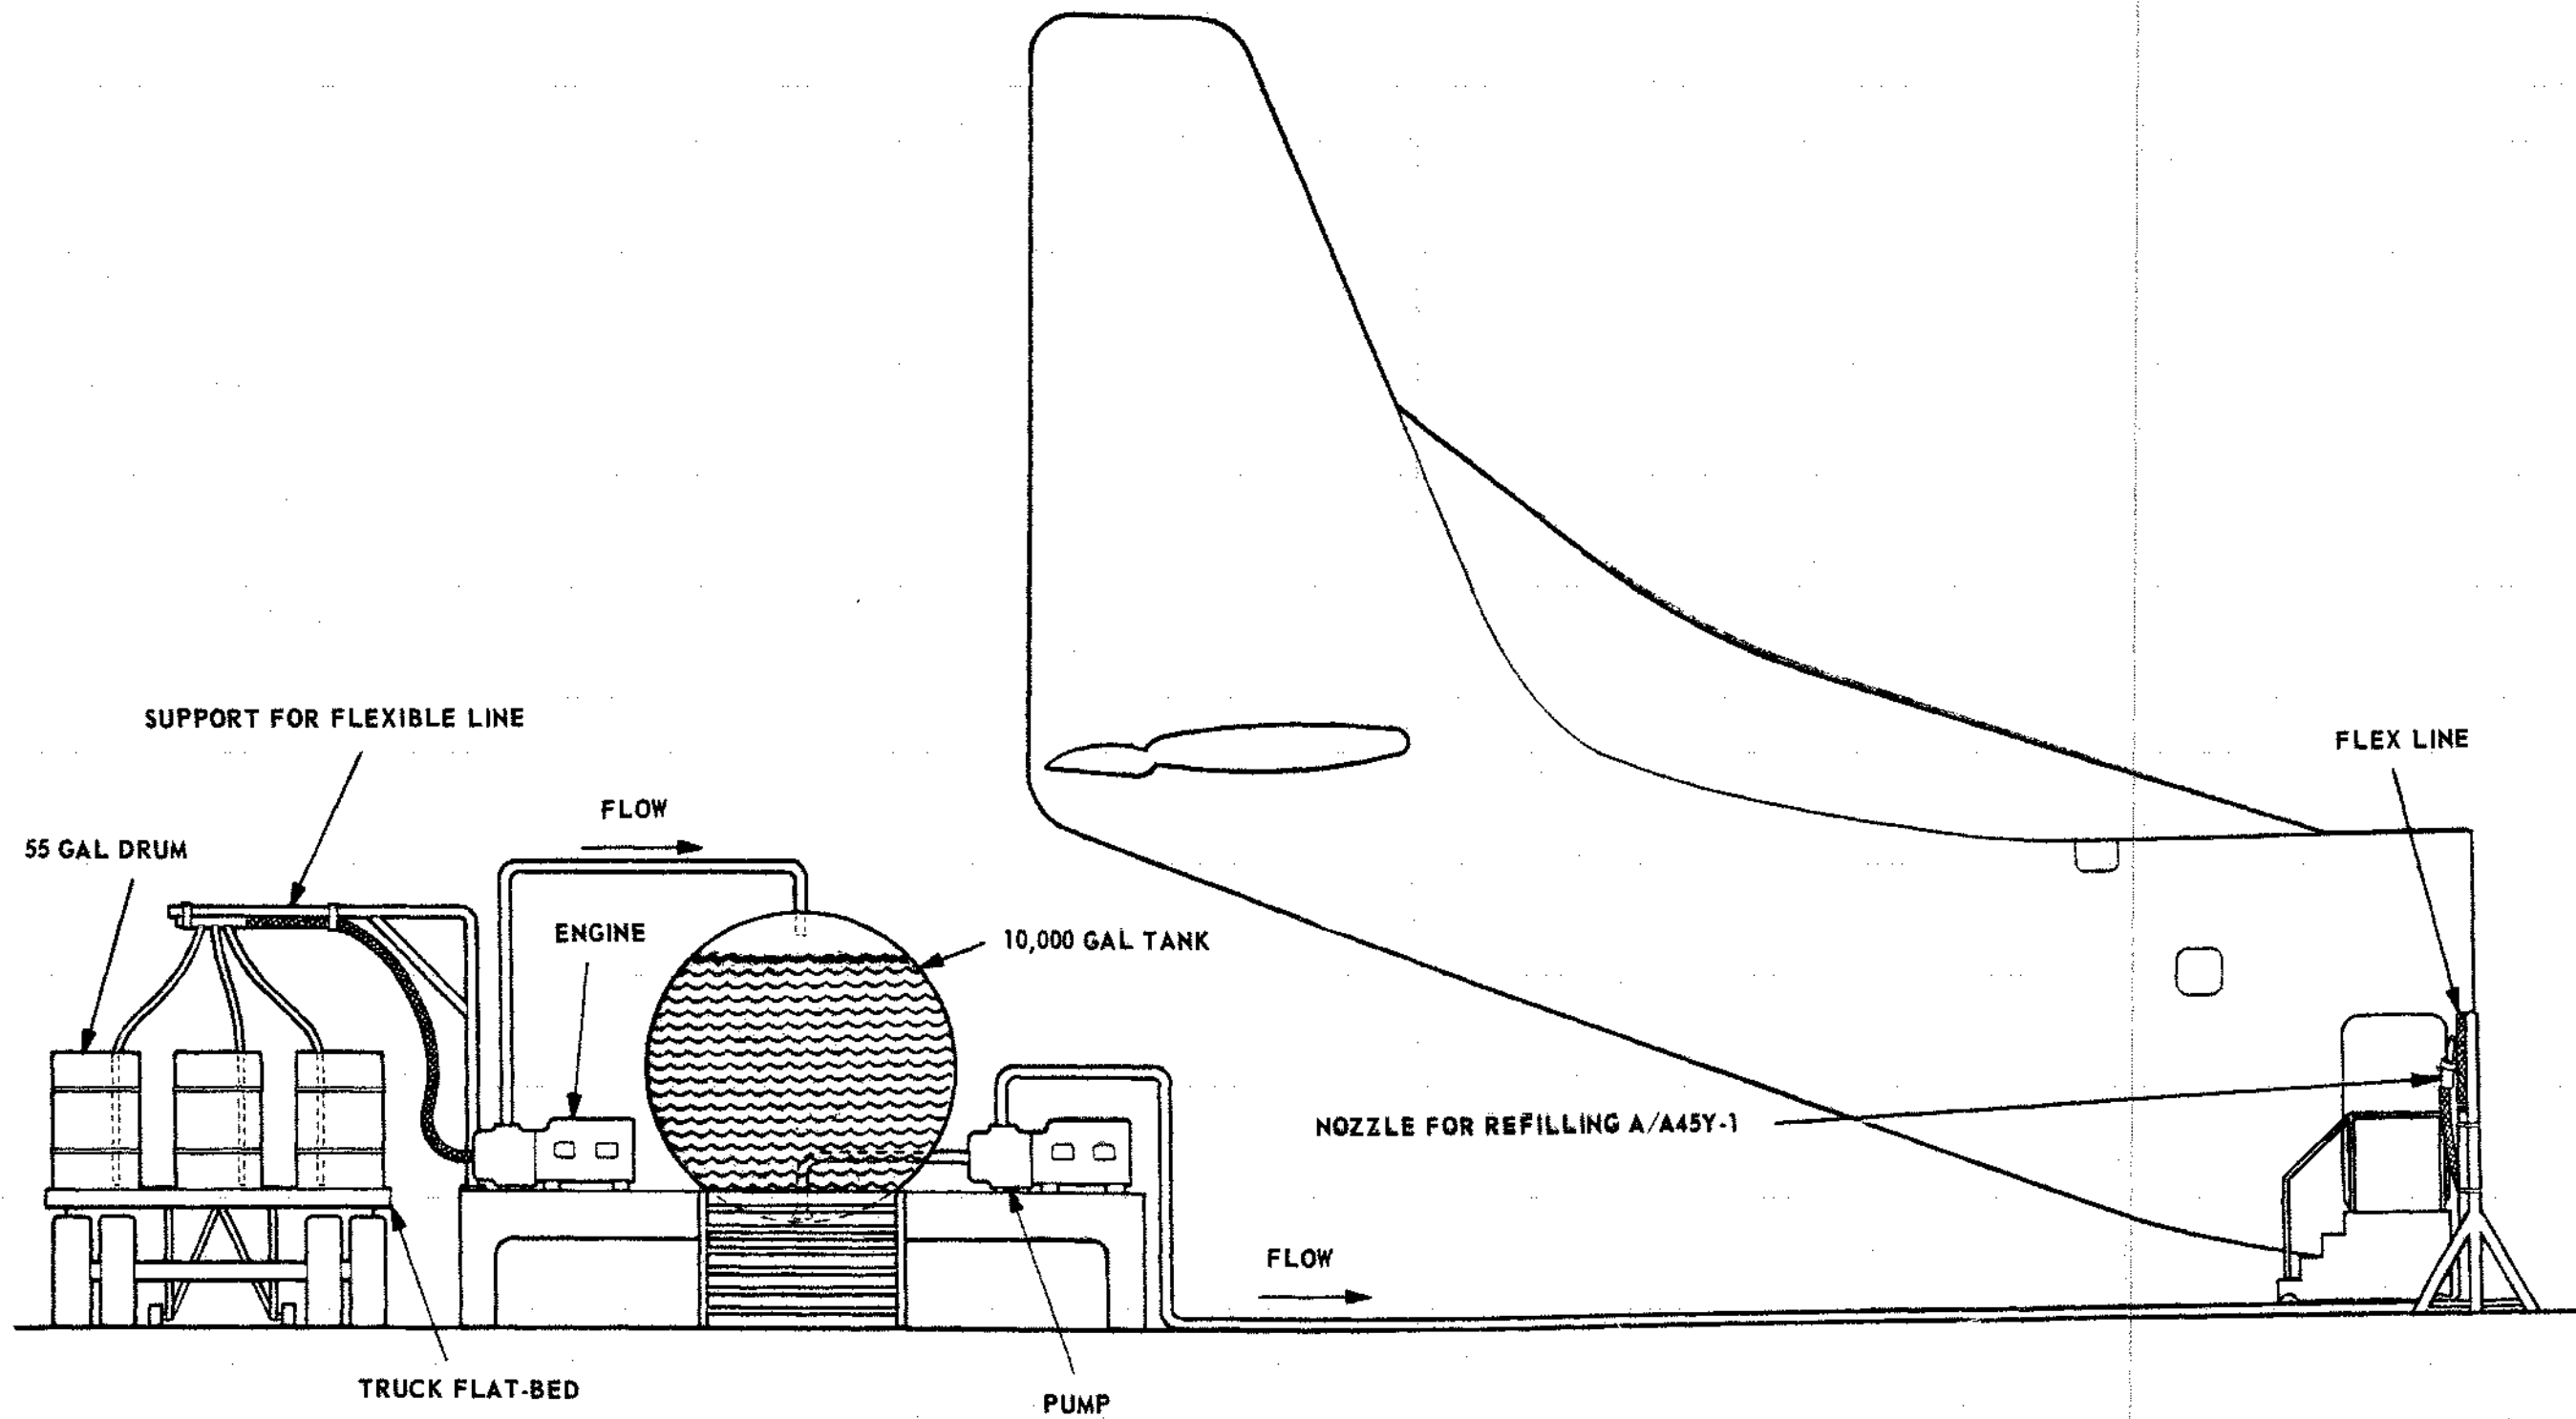
Figure 16. Defoliant Handling System Components

The engine and pump unit is identical to that incorporated in the A/A45Y-1 dispenser and is specifically engineered for effective transfer

of defoliant under sustained operation. The engine is a government standard, air-cooled, four cylinder, four stroke cycle, horizontally opposed model modified for remote control when mated with the control console. The engine is available in large quantities, economical to operate, proven in performance, and easily maintained due to maximum accessibility. It is designed to operate a minimum of 1500 hours at rated load and speed between major overhauls. Its extensive use in defoliation operations tends to standardize maintenance and provide a spare parts source through controlled cannibalization.

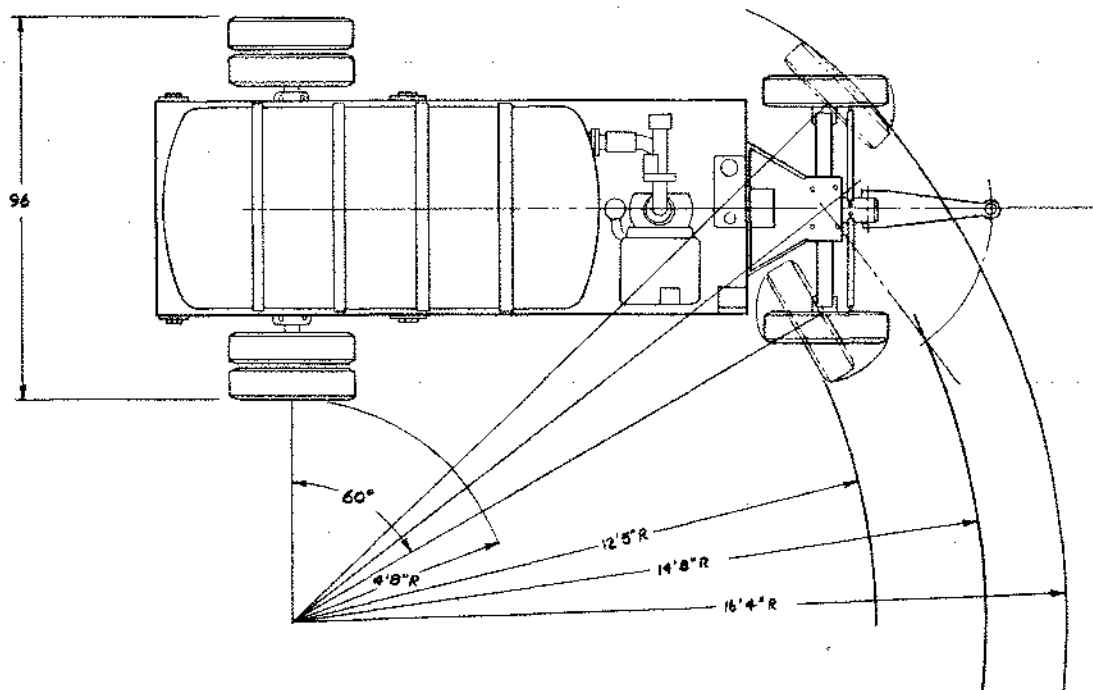
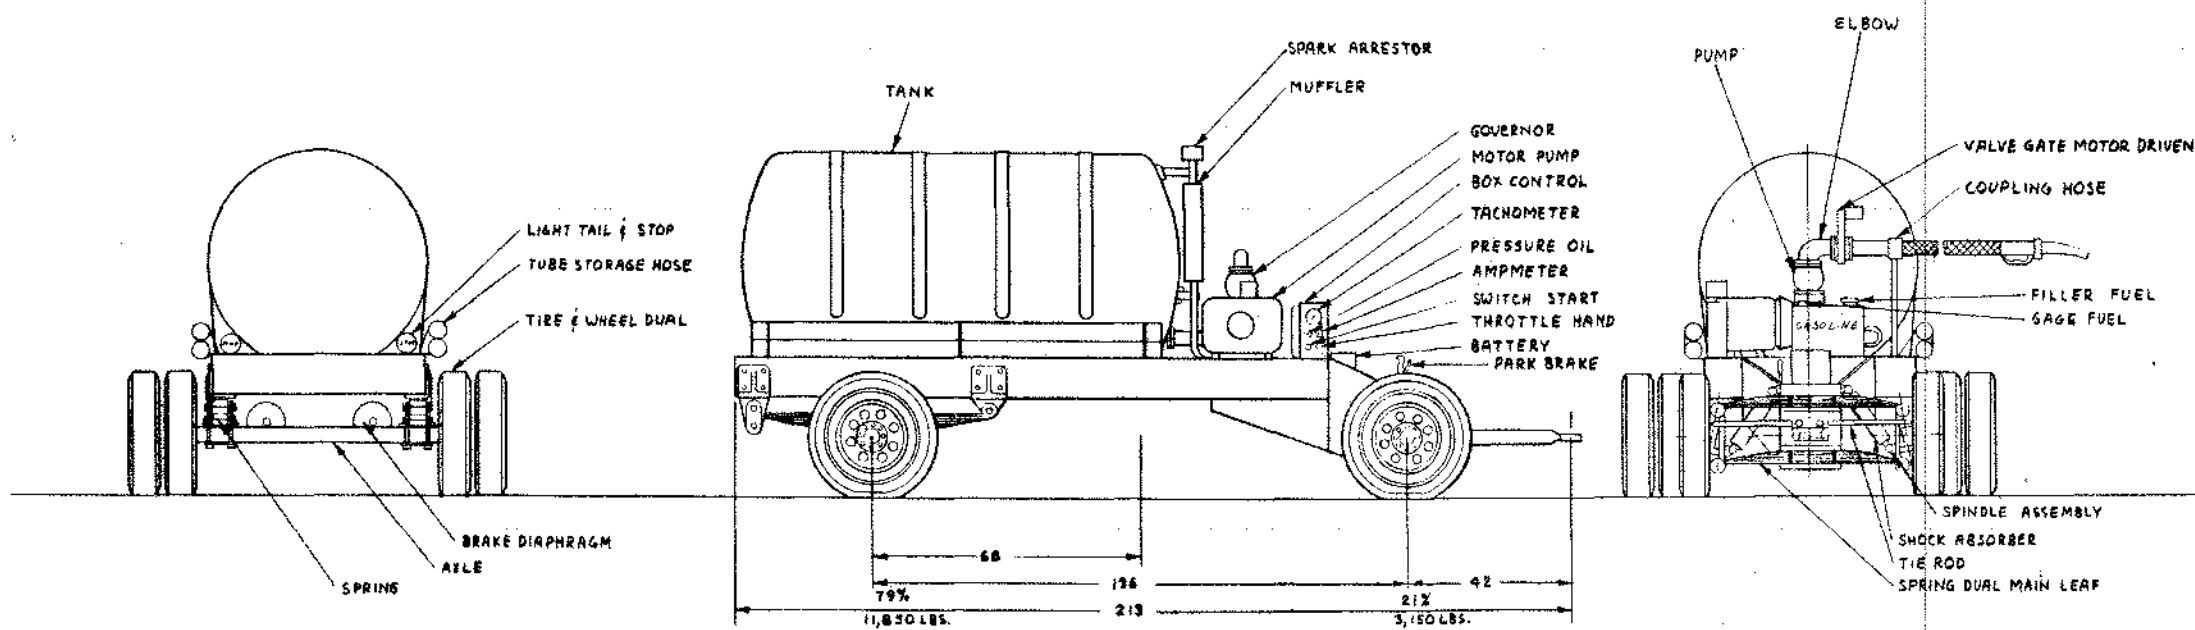
Figure 17. Tank Trailer Defoliation Liquid Refill

DESCRIPTION
TANK TRAILER DEFOLIATION LIQUID REFILL

MADE FROM HAYES INTERNAL DEFOLIATION DISPENSER, MODIFIED FOR GROUND SUPPORT. STANDARD MILITARY WHEELS & TIRES ARE USED. 16 X 8 10 PLY FLAT BASE RIMS. WEIGHTS, EST. EMPTY WEIGHT 4,000 LBS. LOADED 13,000 LBS. 1000 GAL. CAPACITY. BRAKES REAR WHEELS ONLY. BESLER OR WESTINGHOUSE AIR, WITH HAND PARKING, MOTOR DRIVEN GATE VALVE WITH REMOTE CONTROL STATION FOR INSIDE AIRCRAFT REFILL OPERATION CONTROLLED BY OPERATOR INSIDE AIRCRAFT TO PREVENT SPILLING. HOSE 3 IN. DIA. X 10 FT LONG 4 HOSES WITH QUICK CONNECTORS CARRIED IN TUBES. FRONT SUSPENSION, DOUBLE TRANSVERSE SPRING PROVIDES HIGH LOAD CAPACITY GOOD STEERING PROPERTIES AT ANY SPEED ON FIELD OR ROAD. TIGHT TURN RADIUS PROVIDES HIGH MANEUVERABILITY WITH SAFETY.

The portable defoliant handling unit idea is conceived for military installations where limited servicing of A/A45Y-1 dispensers might be required. The trailer is capable of traveling at faster speeds and for greater distances than the A/A45Y-1 dispenser and, being a powered unit, it speeds up the servicing of the dispensers installed in aircraft. Overall dimensions are kept within limits which will permit air transportation of loaded units to isolated landing fields or airstrips.

Technical data and capabilities are contained in figure 17.
